# Condition Monitoring Pays Off for Finnish Pulp & Paper Mill

*How UPM Wisaforest Uses System 1® Software for Improved Asset Management*

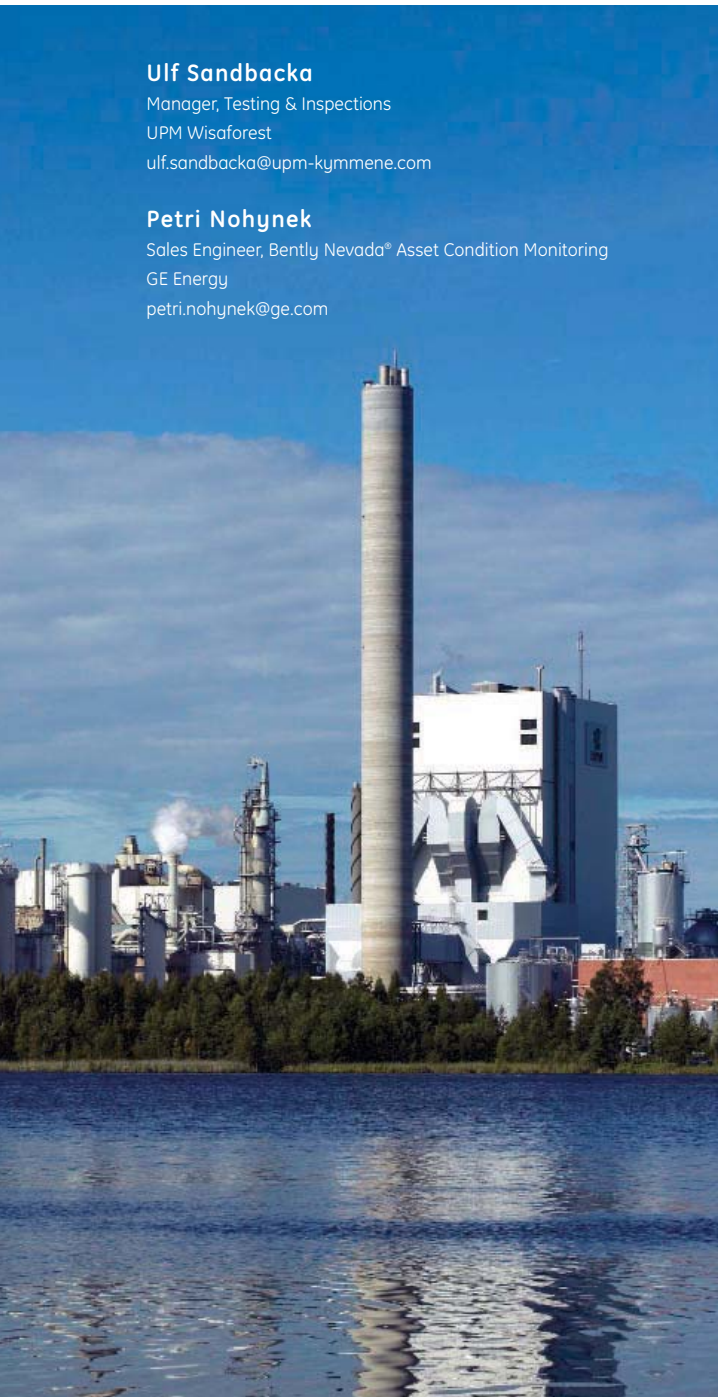
**The new recovery island at UPM-Kymmene's Wisaforest pulp and paper mill in Pietarsaari, Finland. The result of the WISA 800 REC project, the new unit boosted the mill's pulp output to 800,000 ADt/a while decreasing environmental discharge to best-available-technology levels.**

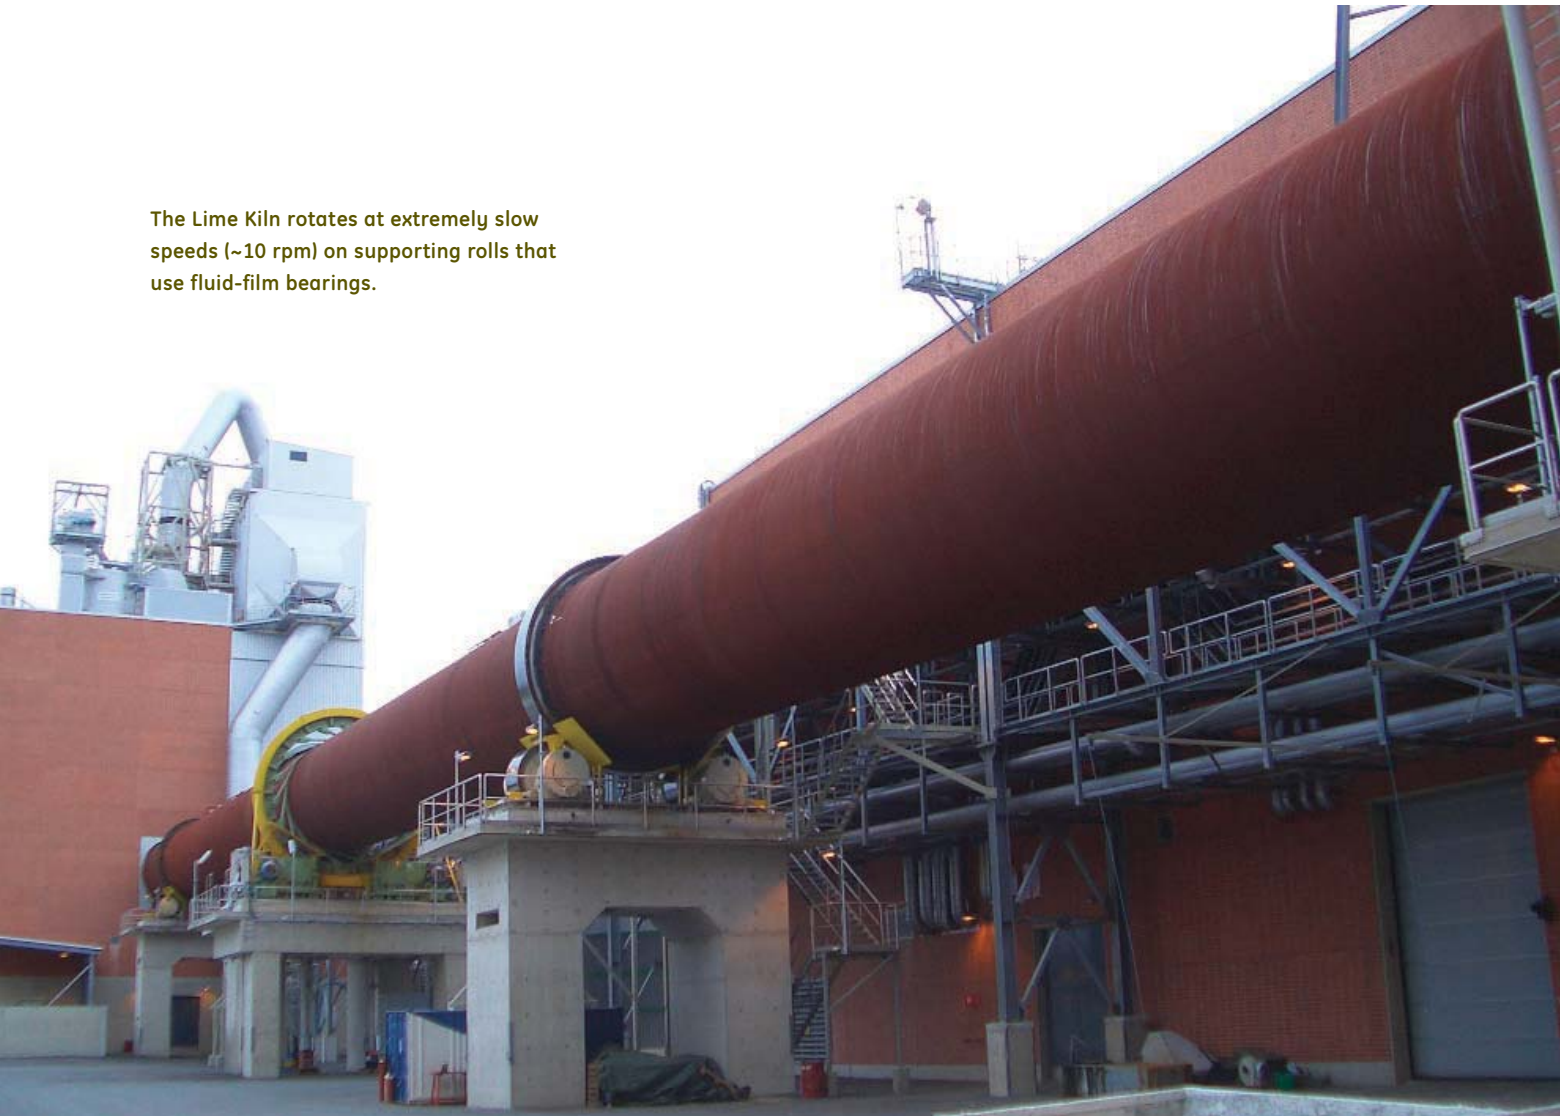
The Lime Kiln rotates at extremely slow speeds (~10 rpm) on supporting rolls that use fluid-film bearings.

The massive bearings on the lime kiln supporting rolls are fluid-film type and the rotational speed is very low (approximately 10 rpm). Initially, the plant determined that these 16 bearings would use X-Y proximity probes for vibration monitoring. However, this decision was made late in the project, after the kiln had been supplied and installed, making transducer retrofits considerably more difficult than if this had been specified to the OEM for factory installation of probes. Consequently, it was necessary to equip these bearings with accelerometer transducers. It was recognized that this was not an ideal application, but project constraints dictated this compro-

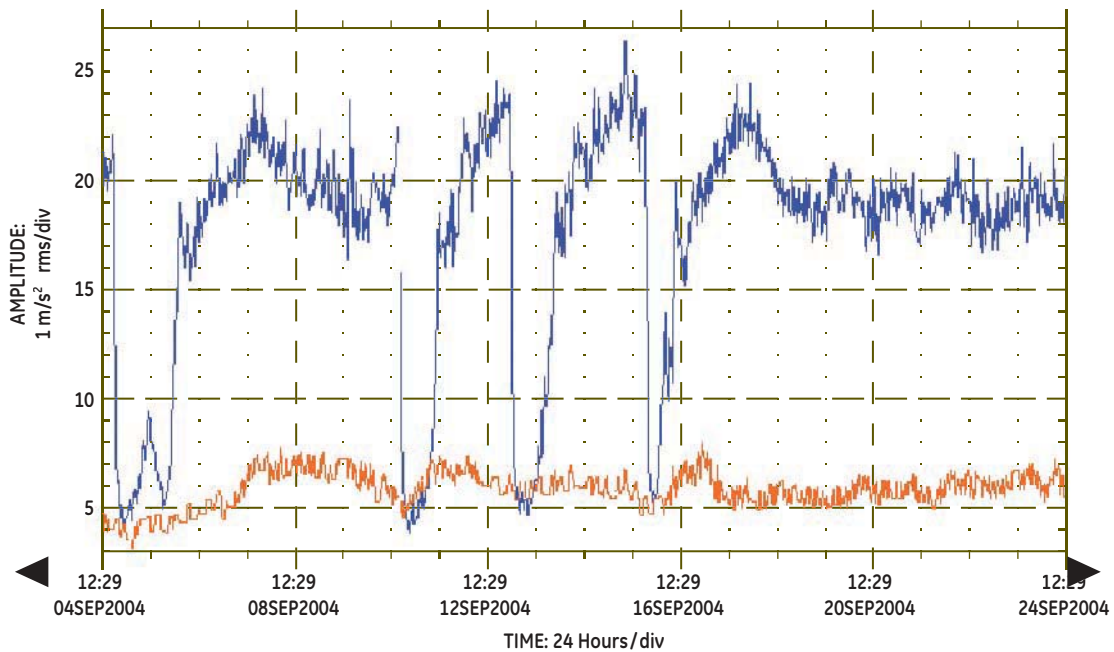
Figure 1 – Trend of high-frequency vibration amplitude from inboard bearing (blue) and outboard bearing (orange) showing elevated vibration levels at inboard bearing. The “dips” show the intermittent operation of the lubrication system, allowing the inboard bearing vibration to temporarily decrease to normal levels.

The secondary air fan is a 600 kW direct-driven over-hung fan that is critical for the recovery boiler operation. Shortly after startup, abnormal changes in trends of the high-frequency data from the inboard bearing accelerometer were noted. Figure 1 is taken directly from the System 1 software, showing a 2-month trend of high-frequency data from the accelerometers on the inboard and outboard bearings. The elevated levels on the inboard bearing (blue) compared to the outboard bearing (orange) are readily apparent.

Spectral analysis suggested that the bearing's outer ring was wearing prematurely, and the root cause was ultimately traced to problems with the bearing lubrication system. The prominent "dips" in the trend plot correspond to intermittent operation of the lubrication system, showing a marked decrease in vibration for the inboard bearing when lubrication was flowing properly.

Even though root cause was identified, implementing the changes to the lubrication system was a lengthy process, and the machine was required to operate in the interim. Thus, although the bearing had to be replaced twice during the first six months, the CM system proved very useful in scheduling these replacements, allowing the plant to monitor bearing degradation closely and intervene at the right times, before catastrophic bearing failure and collateral machine damage occurred. Also, these outages could be planned, allowing the bearing change-outs to be performed when impact to production was minimized.

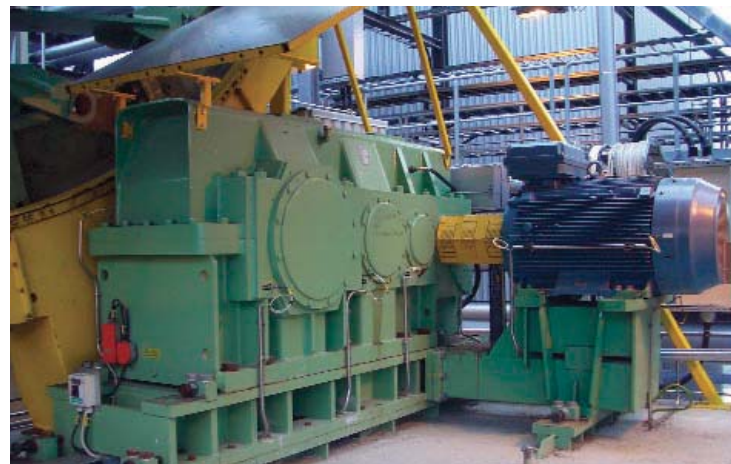
One of two drives for the plant's massive Lime Kiln.

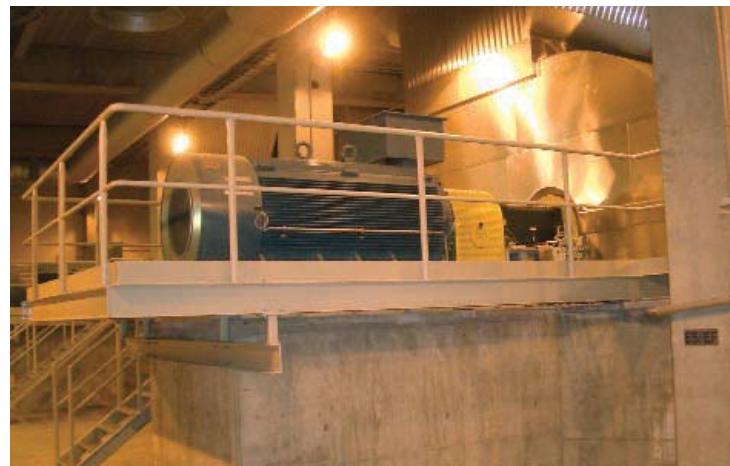
Access platform for Exhaust Gas Fan #3.

The official dedication for the WISA 800 production unit took place on 24 August 2004. The Prime Minister of Finland was in attendance, and, as part of the ceremonies, pushed the “maximum operation” button, allowing the recovery boiler to reach world-record production capacity for a time. This mode of operation required the exhaust gas fans to run faster, and the CM group began to notice an increase in 2X vibration amplitudes on fan #3, as evident in the APHT plot of Figure 3.

Closer examination revealed that the outboard bearing of fan #3 had likely sustained a crack in the inner ring, which can be noted in the timebase of Figure 4. The characteristic “ringing” phenomenon observable in the timebase occurs at the inner ring defect frequency as the cracked inner ring repetitively rotates through the load zone and the rolling elements contact it with greatest force.

Subsequent to that event, the bearing has been monitored closely, allowing operations to continue without replacing the bearing. The defect does not appear to be progressing and is not serious enough to necessitate a bearing replacement until a more convenient time can be scheduled.

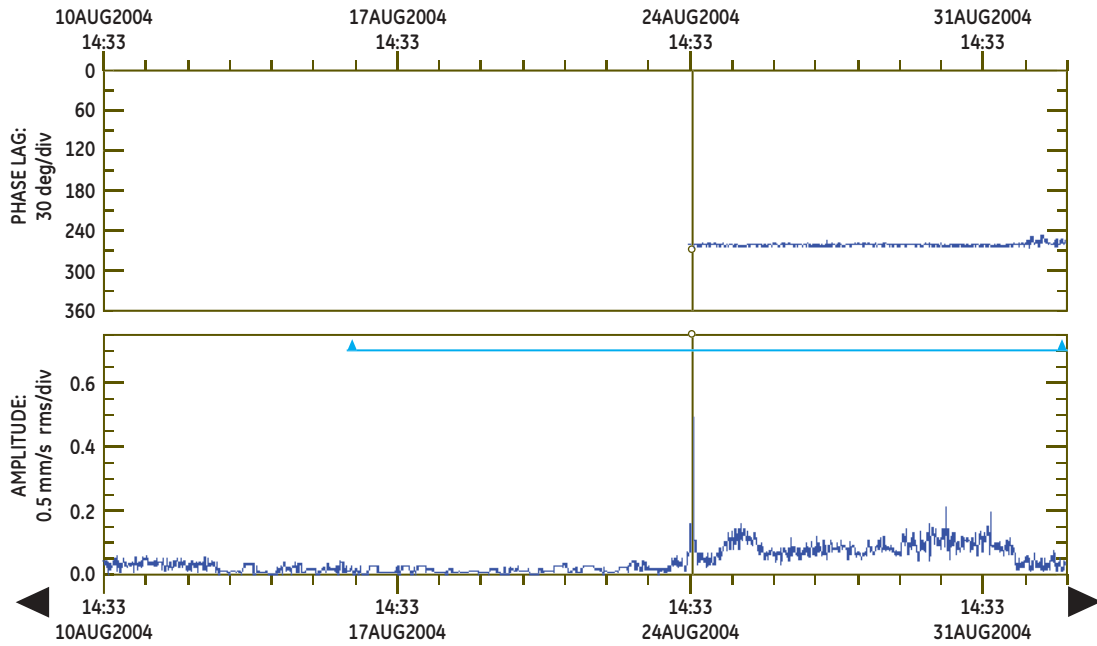
Figure 3 – Amplitude/Phase/Time (APHT) plot of 2X vibration data from outboard bearing accelerometer on Exhaust Gas Fan #3. Note that amplitudes prior to the cursor location on the plot were so low that phase readings would not trigger consistently; as vibration amplitudes increased, phase readings stabilized.

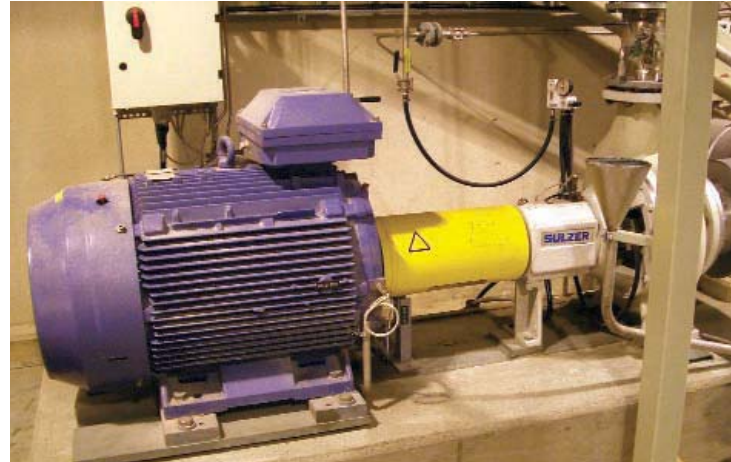
White Liquor Pump showing motor and coupling guard.

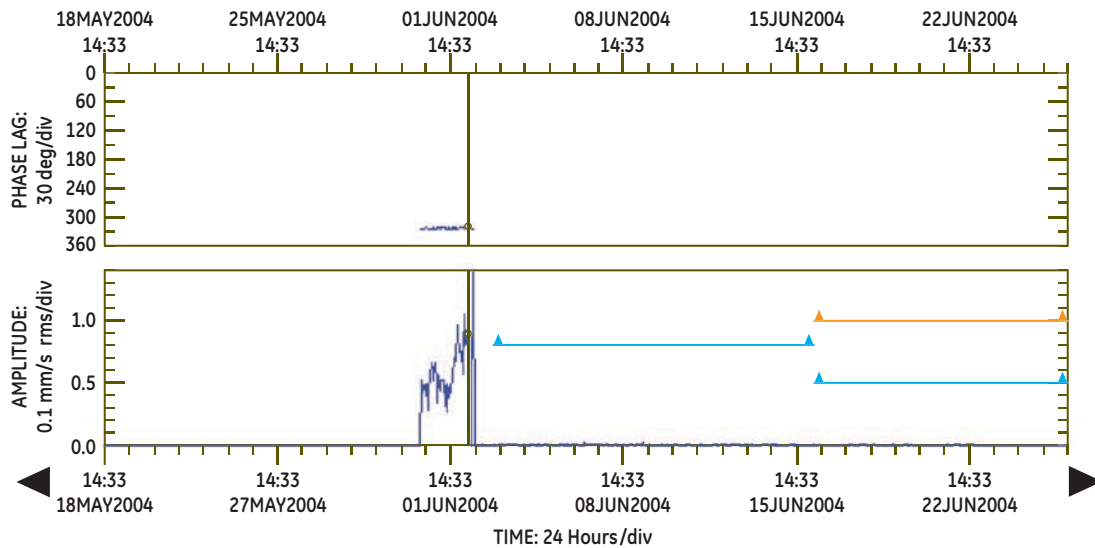
**Figure 5** – Amplitude/Phase/Time plot of 2X data from accelerometer on motor driving the white liquor pump. Note abrupt increase in vibration amplitude beginning on 30 May 2004. A deteriorated coupling insert was found to be the cause, and was replaced on 1 June 2004, returning vibration levels to normal values.

A typical pulp mill has hundreds of pumps. At Wisaforest, 15 of these were deemed suitably important to connect to the CM system. In late May 2004, as shown in Figure 5, increased vibration levels were noted on the motor driving the white liquor pump. Further analysis revealed that the rubber element in the coupling had deteriorated, allowing metal-to-metal impacting. The coupling was subsequently repaired and vibration levels returned to normal.

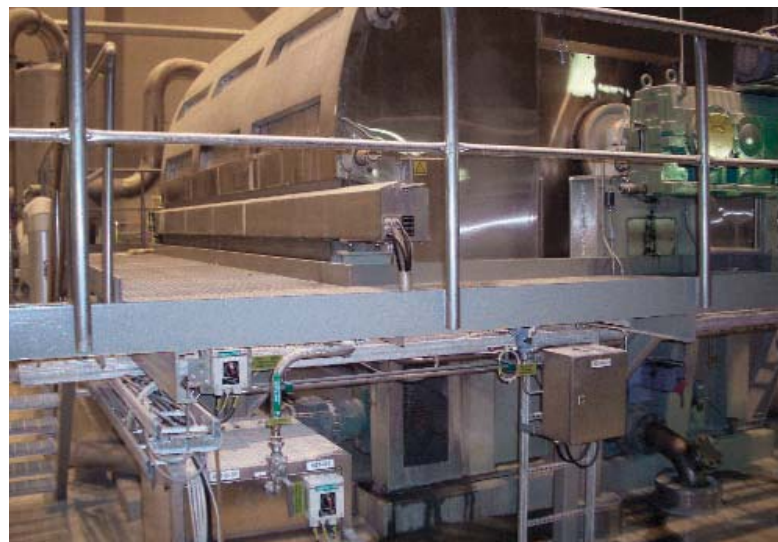
The rotary filter. Accelerometers were mounted on the filter bearings and the gearbox (green, upper right); however, the problem was traced to an unmonitored mixer underneath the filter (concealed in lower left corner of photo).

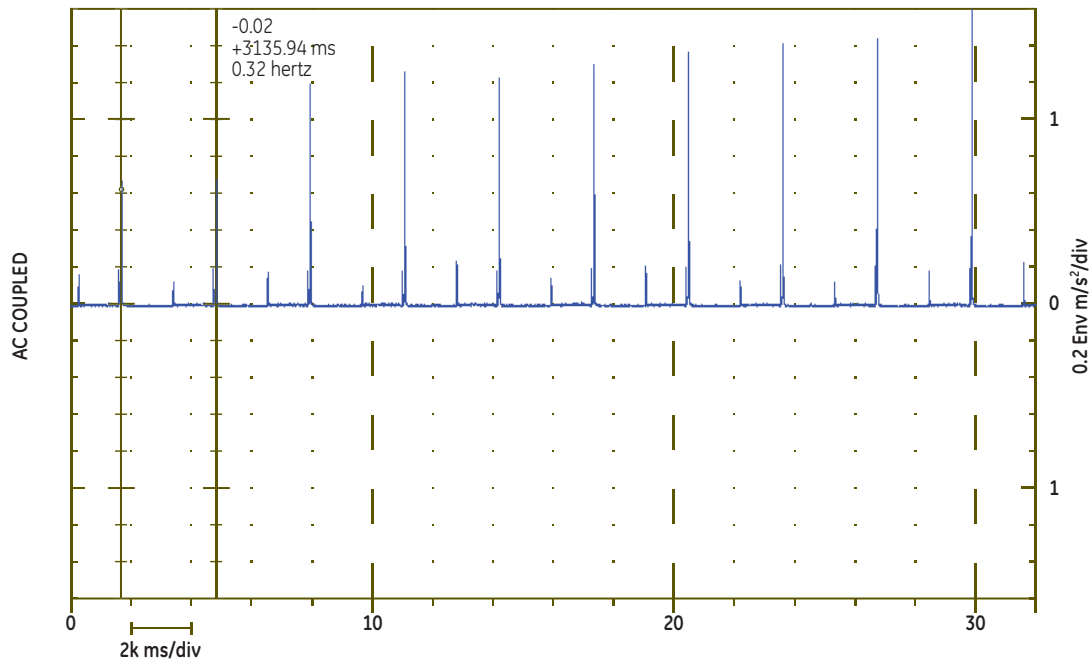
**Figure 7** – Timebase plot of enveloped acceleration showing clear evidence of impacting. Spectral analysis yielded frequencies that did not coincide with bearings used on the rotary filter, leading the plant to look for faults elsewhere.

The enveloped acceleration timebase (Figure 7) showed very clear evidence of periodic impacting, but examination of the spectral components did not yield any frequencies corresponding to the bearing geometries or rotative speeds of the filter or its gearbox. A visual examination of the filter gave the reason: it was not the filter at all, but rather a separate mixer, located below the filter, with a damaged bearing. Although the mixer was a *totally unmonitored machine*, the impact vibrations occurring from its faulty bearing were being mechanically coupled into the accelerometer on the filter bearing, located nearby. The root cause was found to be broken lubrication piping feeding the mixer bearing, which was subsequently repaired. However, the bearing had been irreparably damaged and had to be replaced. This case history is particularly noteworthy
